Removing output shaft from final drive,  
refer to 33 21 000.

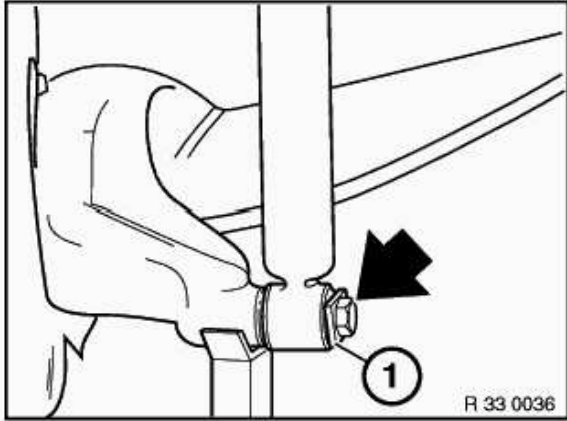
If necessary, unscrew stabilizer on trailing arm.

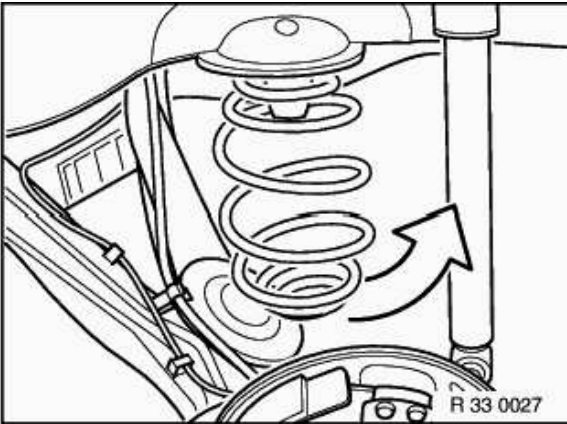
Support trailing arm.

Unscrew screw.

Use washer (1).

Tightening Torque,

refer to Technical Data 33 52 1AZ
